# 1940s semi-detached Cotswolds

Case study 13

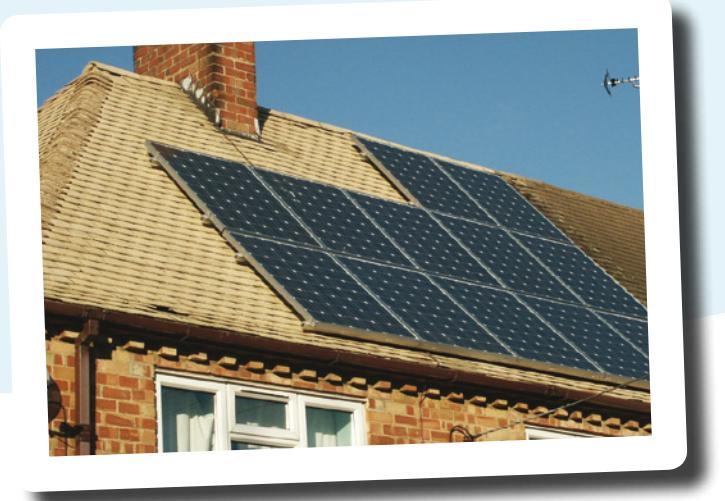
Photovoltaic panels on south facing rear roof

The panels are a 2m<sup>2</sup> evacuated tube system mounted on the west facing roof at the side of the property, with the tubes rotated slightly towards south. The larger south facing roof

was kept for the PV array. The cost of installing the new boiler, cylinder, solar tubes and all associated works was around £6,300.

The 2.2kWp photovoltaic panels installed were sized to maximise use of the roof area and budget available. This cost just over £9,000, and is anticipated to be recouped in approximately 10 years.
