1970s timber frame house Chalford

Case study 9

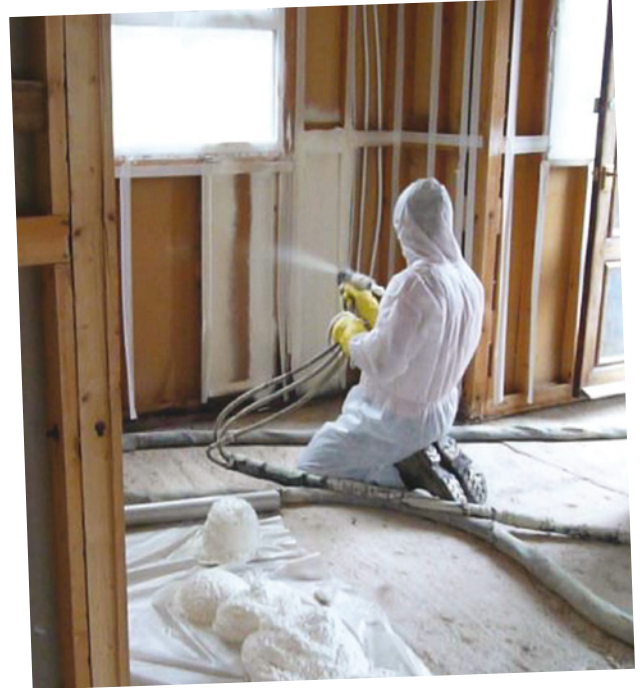
Spraying foam insulation into timber frame walls

The external walls consisted of a timber frame sandwiched between timber cladding on the outside and plasterboard inside, and had very little mass or heat retention. As the frame is based on four foot squares and has many smaller areas it was not practical to blow insulating material into the cavities. One wall in the bathroom was DIY insulated with solid foam board, but this was found to be very time consuming, and the owners were aware of the importance of getting a good fit to prevent air movement around the insulation. After investigating the options, the final decision was to have spray foam insulation sprayed into all the cavities. The family did the preparatory work themselves, removing the plasterboard from the external walls so that the company could install the insulation to all the walls at once, without having to make repeat visits.
